# The 20-Year Pool: Maximizing Lifespan, Material Selection, and ROI

An Architectural and Financial Guide  
for the Educated Homeowner

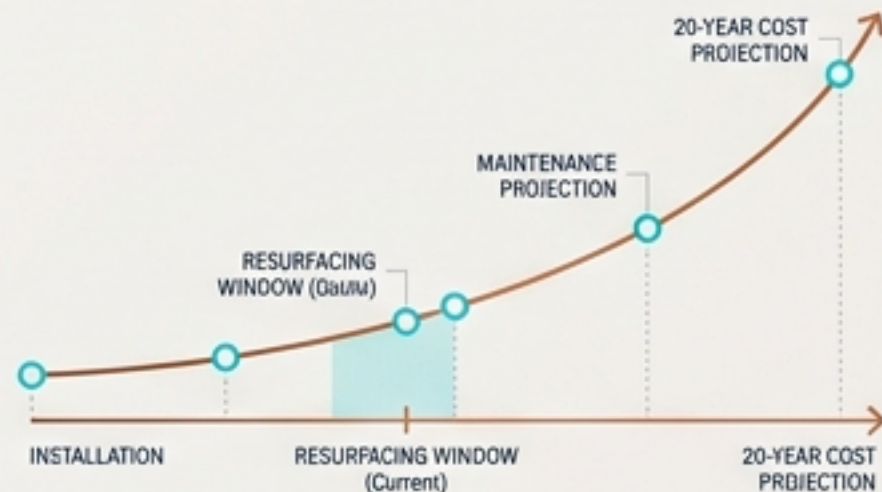
SECTION A-A

# Calculating the Total Cost of Ownership (TCO)

$$\left( \text{Upfront Material Cost} + \text{Installation Labor} \right) \div \left( \text{Expected Lifespan in Years} \right) = \text{True Cost-Per-Year}$$

A cheap, short-term fix guarantees a high Cost-Per-Year. Treating the pool as a financial asset requires maximizing the denominator (**Lifespan**) through premium aggregates and strict installation standards.

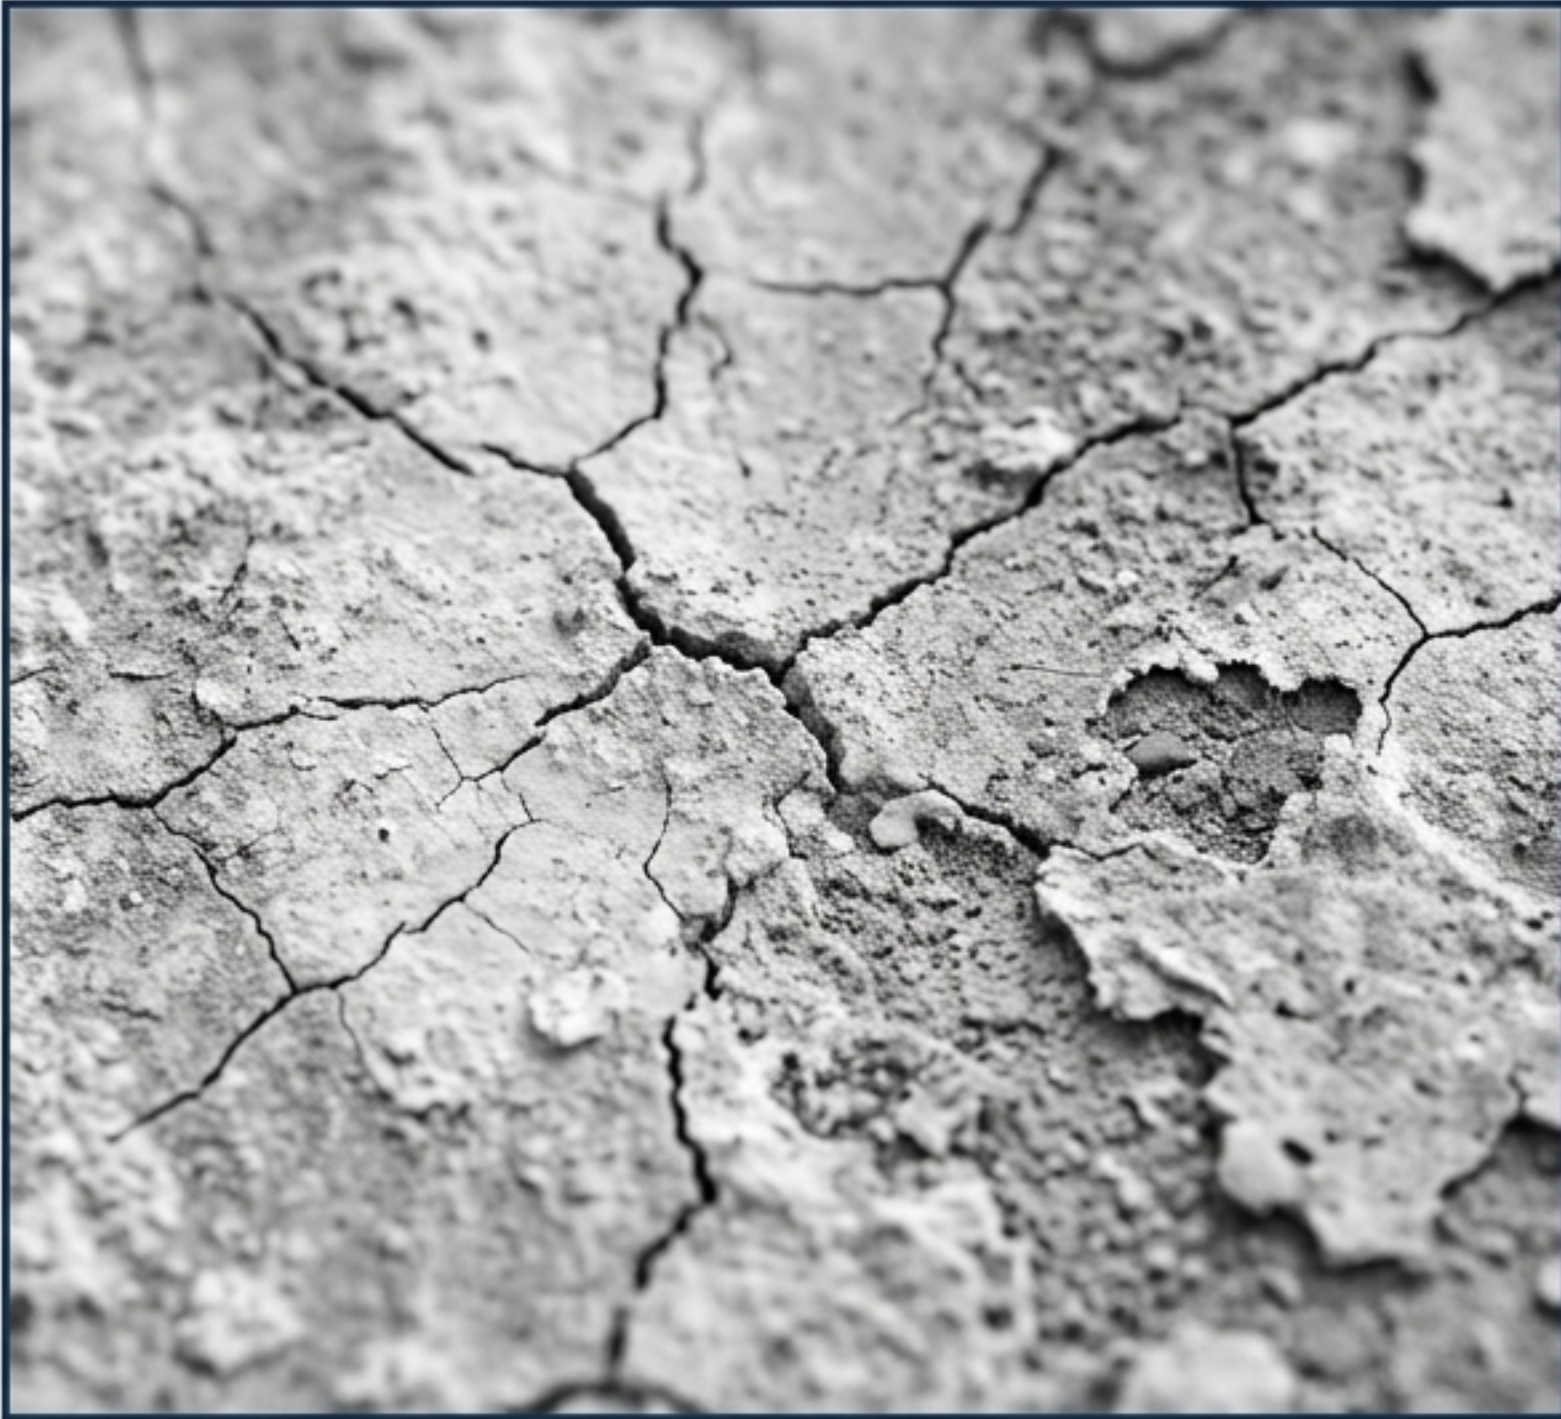
# The Illusion of Savings: Traditional Marcite

Marcite consists of a simple Portland cement and sand mix. It offers a low upfront price but requires complete resurfacing in under a decade.

Highly reactive to imbalanced water. Improper pH immediately triggers calcium leaching, resulting in a rough, chalky texture.

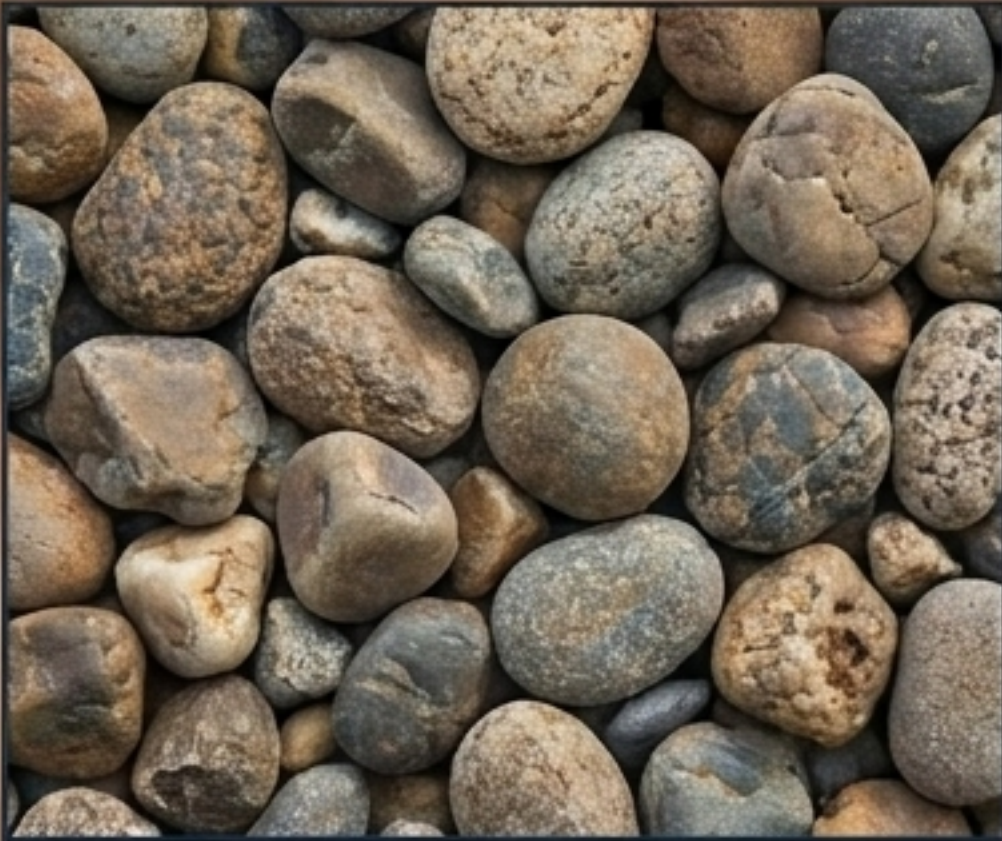
## PebbleTec (Original)

The largest natural pebbles, offering a robust, earthy texture and maximum durability against chemical wear.

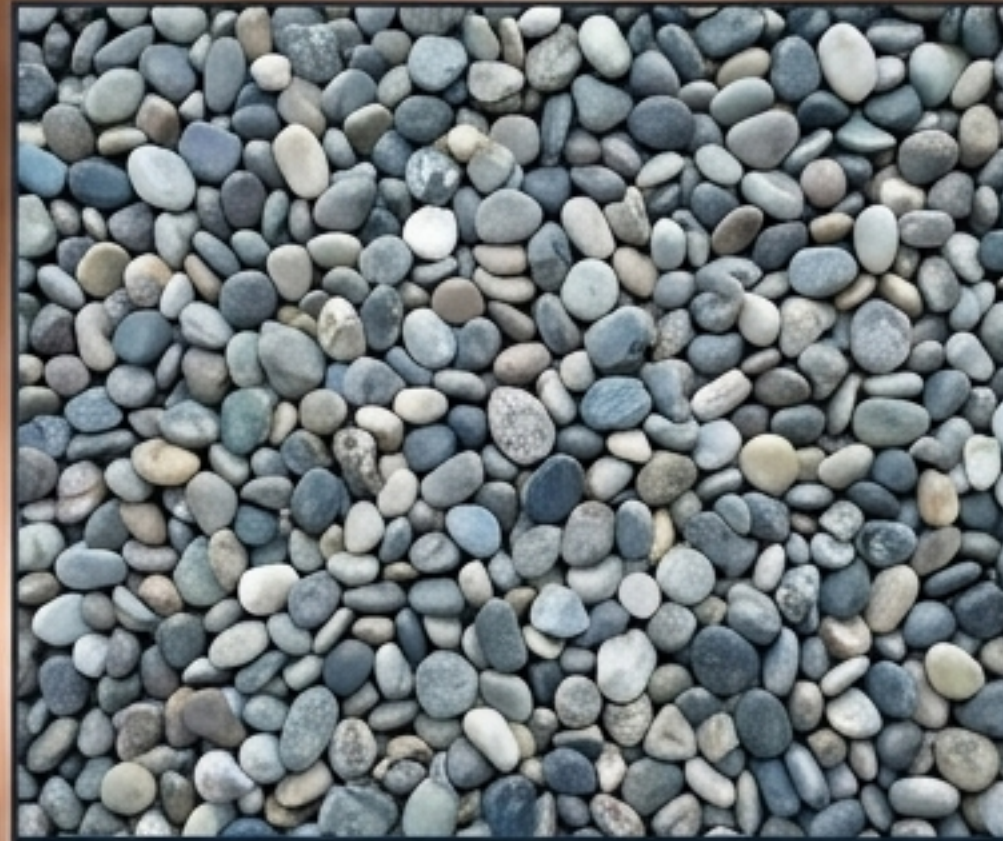
## PebbleSheen

Smaller, finely crushed pebbles that are polished for a more refined, smoother texture while retaining aggregate strength.

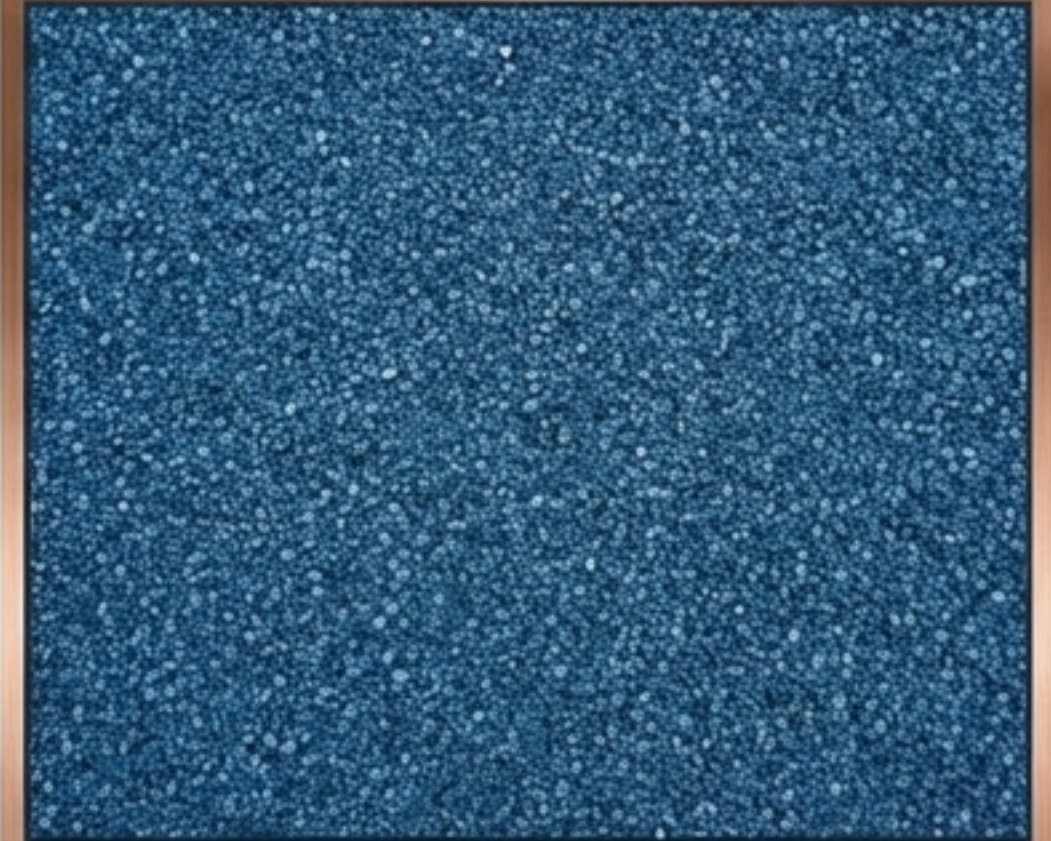
## PebbleFina

The smoothest option, utilizing finely ground stone for a classic look with the fortified endurance of an aggregate.

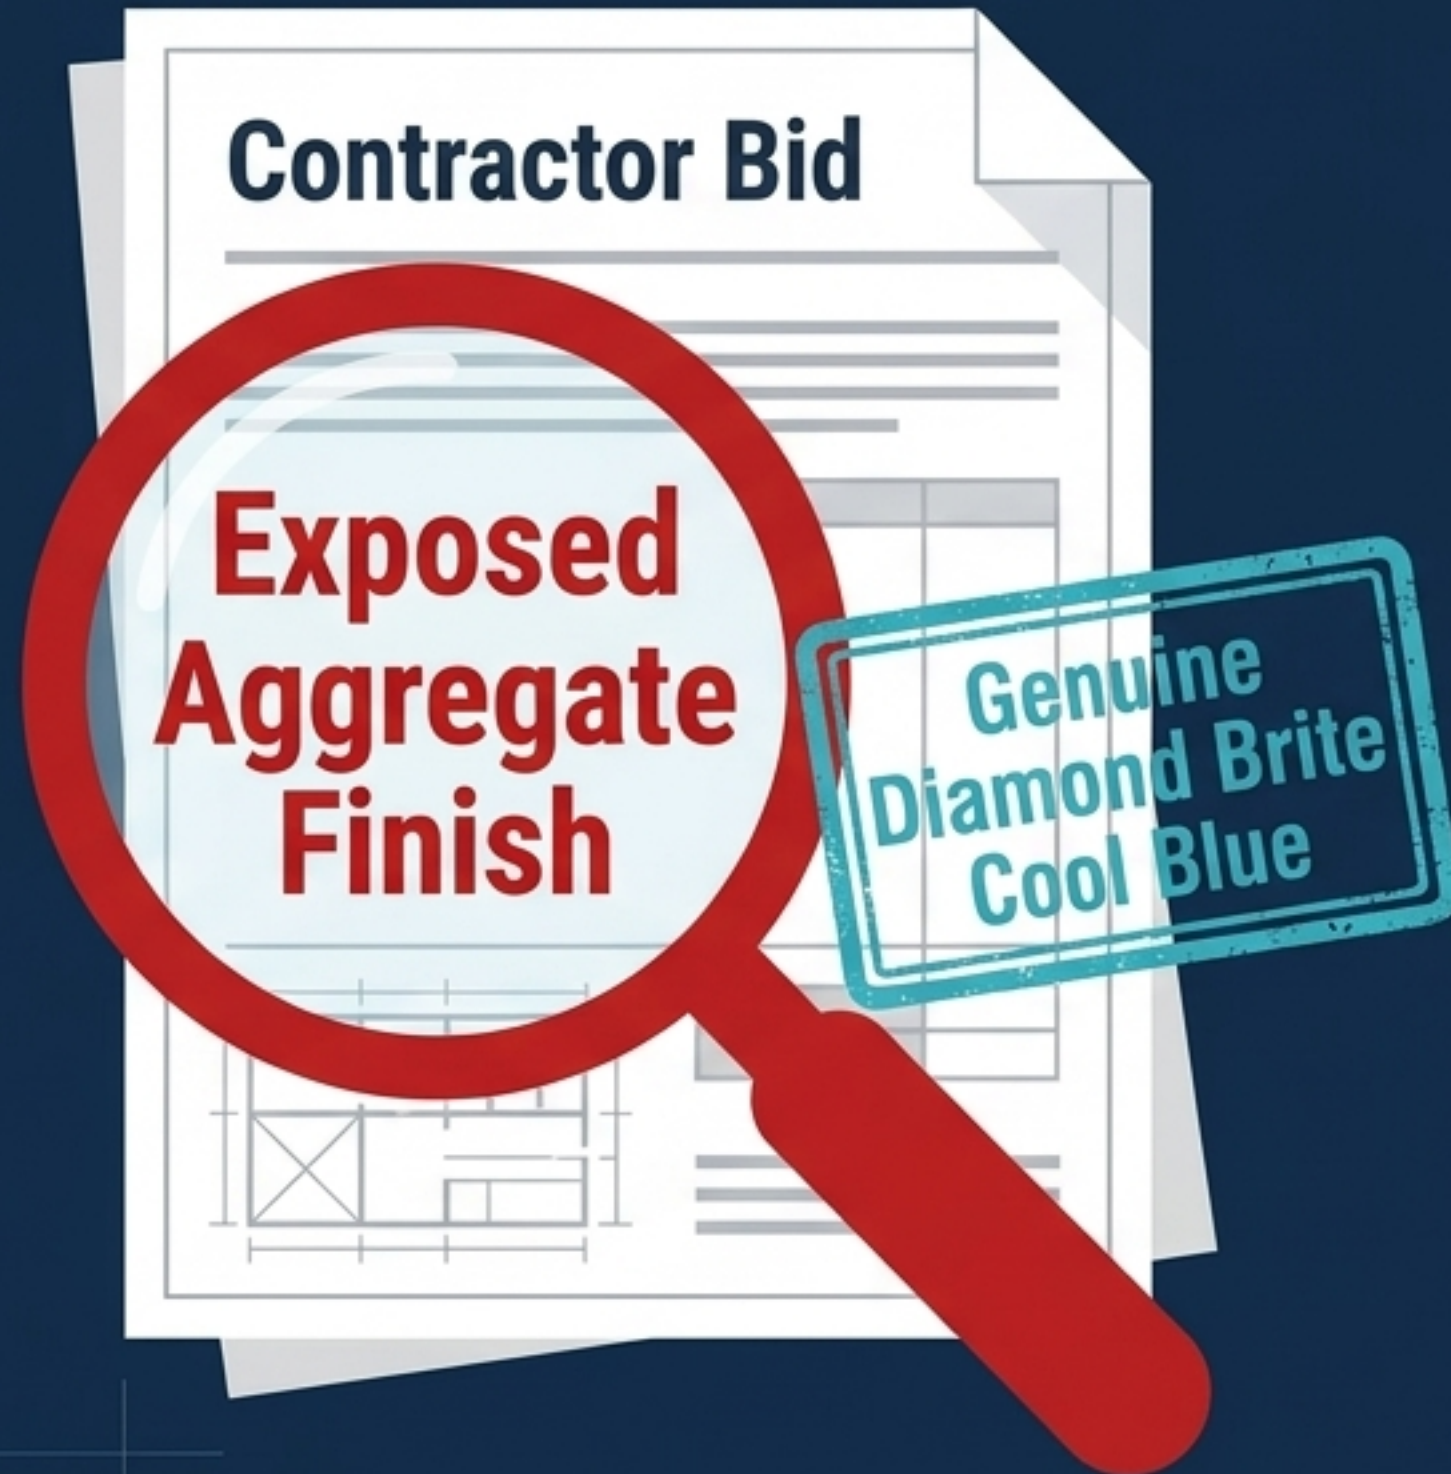
# The Anatomy of a Contractor Shortcut

## The Threat

Unscrupulous contractors use open-ended statements in written contracts to substitute inferior materials behind the scenes.

## The Trap Phrase

"Diamond Brite or other exposed aggregate finish" or simply "Exposed aggregate finish."

## The Solution

Demand absolute specificity. A written contract must legally specify the exact brand, finish line, and color (e.g., SGM Diamond Brite, Pebble Tec).

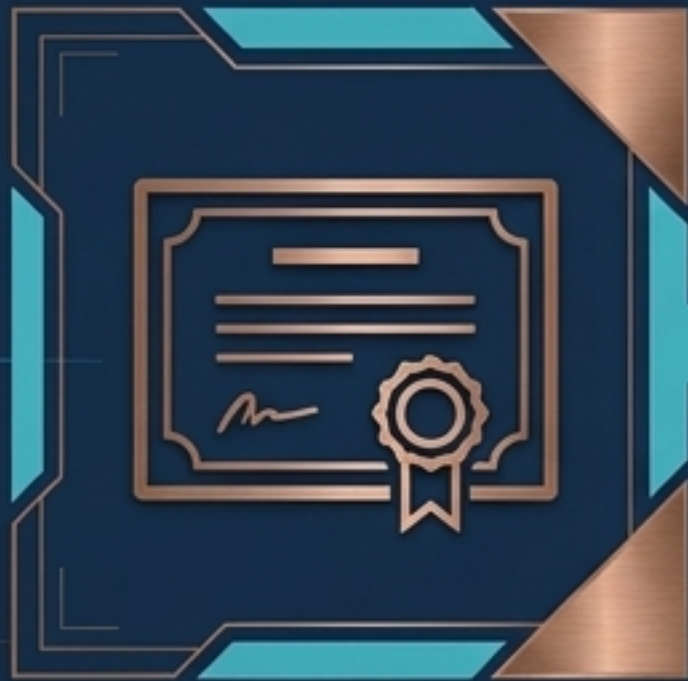
## Step 1: Verify the Factory Trained Certificate

Demand proof that the applicator is officially certified by the manufacturer (SGM, PebbleTec) to handle the specific proprietary formulation.

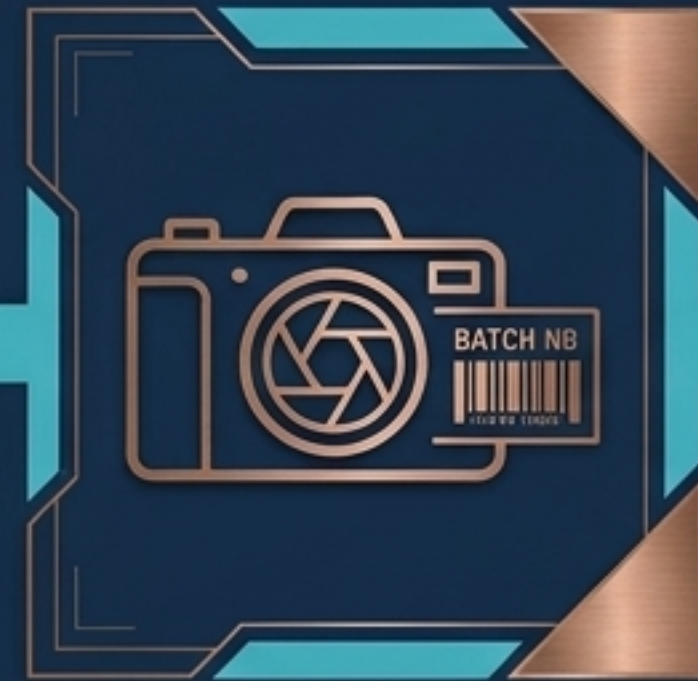
## Step 3: Document the Batch Numbers

Photograph the bag labels. Locate the specific finish batch number (found under the bar code on SGM bags). This is mandatory for your long-term manufacturer warranty.

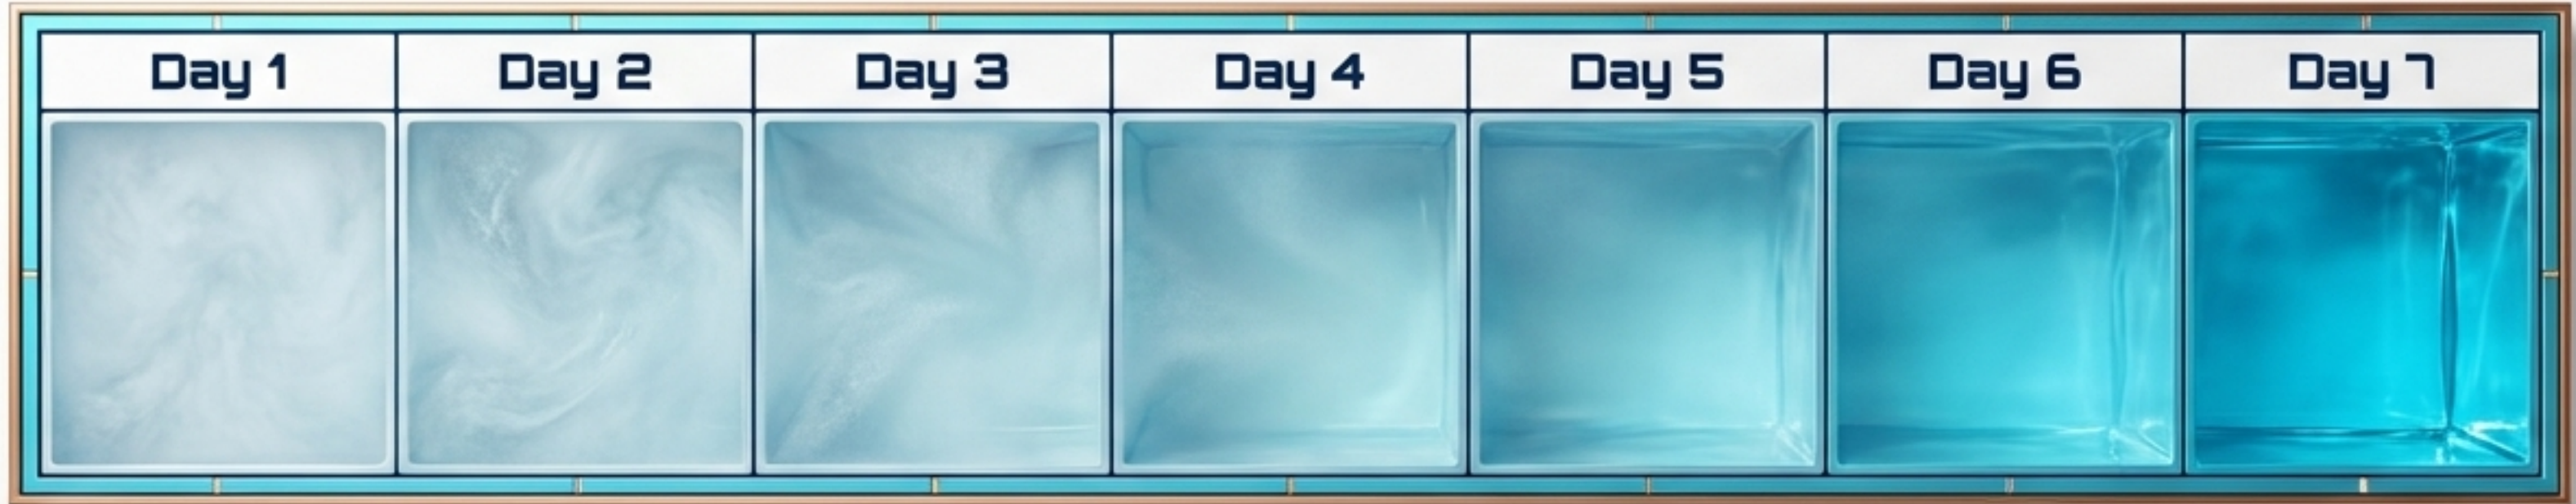
# The Curing Window: Chemistry Over Aesthetics

Plaster and aggregate finishes require time to properly hydrate and cure underwater. Heavy doses of muriatic acid are often introduced to expose the aggregate and balance the fresh cement.

Do not swim. It typically takes 3 to 7 days for the pool to be completely filled, chemically balanced, and structurally safe for use.

Final water color is influenced by pool depth, sun exposure, and surrounding landscaping. The true color will not emerge until the chemical curing process is complete.

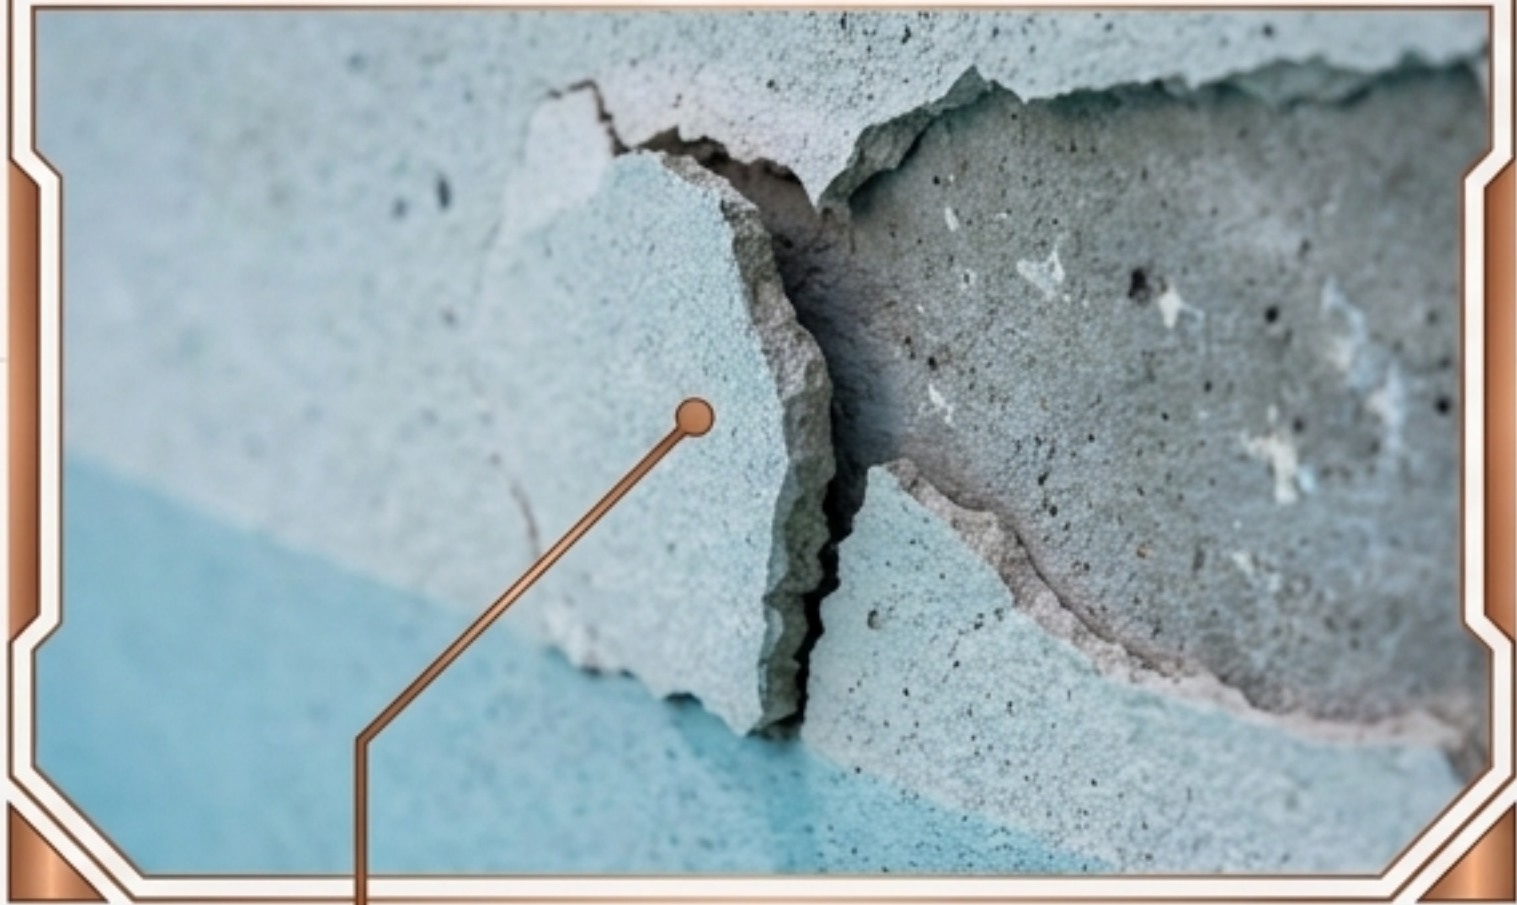
Chipping & Peeling | STRUCTURAL FAILURE

**Diagnosis:** Physical separation of the material from the pool wall indicates a failure in the Bond Kote layer or severely stretched material (violating the 22-sq-ft rule). This triggers warranty action.
